**Flood Control Project Maintenance  
Levee Inspections**  
**LMA District Cover Sheet**  
**Spring 2020 Levee Inspection Results**

**Reclamation District No. 1001 Nicolaus**

**Spring 2020 Levee Inspection Results**

**Levee Inspection Report By Mile - Spring 2020**

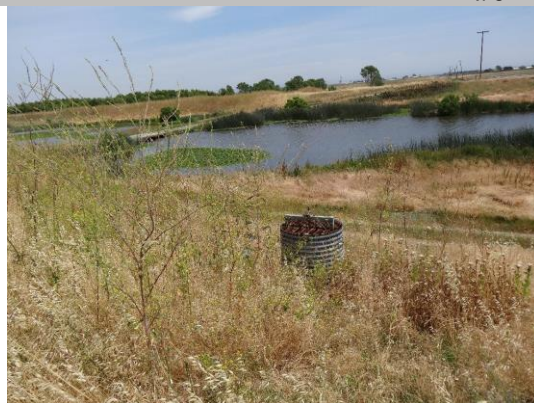
Photo 1 of 3 : UCIP\_SP\_2020\_55197\_23434.jpg

DS\_ID:22615  
 FS\_ID:55197  
 EP\_NO: N/A  
 Repair Type: Non-Urgent  
 Crossing Status: Found  
 UCIP Comments: 08/21/2019 Record has been updated from No Action Needed to Non-Urgent, dense vegetation along the LS slope prevented a thorough inspection. Record updated with USACE O&M reference. (O. Magana - DWR UCIP)05/15/2013 - a concrete vault found off the pipe alignment on LS.- a CMP found across the road on LS.- a slide gate in CMP riser on levee slope on WS. (P. Amaty - DWR UCIP)  
 FIELD\_STRUCT\_DESC: 24-inch corrugated metal gravity drainage pipe through the levee, 15.5 feet below the crown. Slide gate in a 36-inch corrugated metal pipe (CMP) riser on the waterside (WS) slope. Concrete headwall at the landside (LS) toe. Pipe crosses under the channel. [Additional Reference(s): DWR Levee Log, 1993. USACE Sacramento O&M Manual, Unit 142 - Back Levee of Reclamation District No. 1001, June 1959, Revised 04 May 2018, 24-inch pipe (HLM 2.05)].

WS- slide gate in CMP riser on levee slope

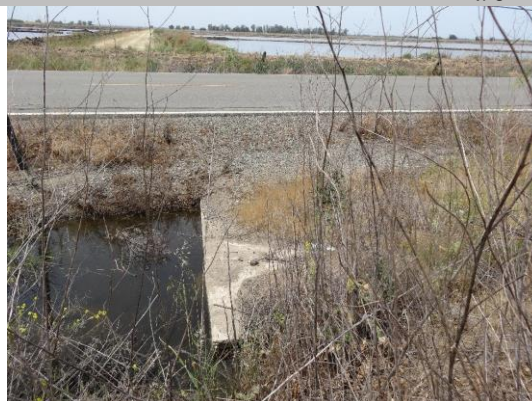
Photo 2 of 3 : UCIP\_SP\_2020\_55197\_23433.jpg

LS- a concrete vault found on levee toe.

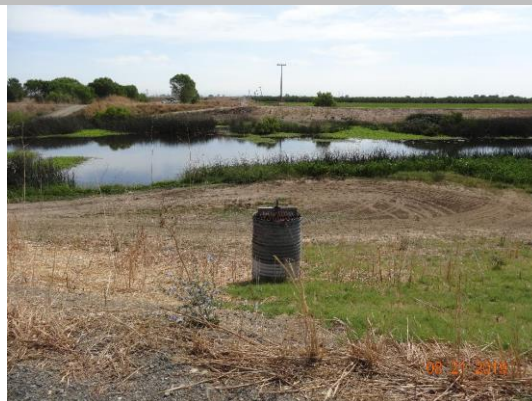
Photo 3 of 3 : UCIP\_SP\_2020\_55197\_81232.jpg

WS view: overview of WS. CMP riser with cover located on WS slope.

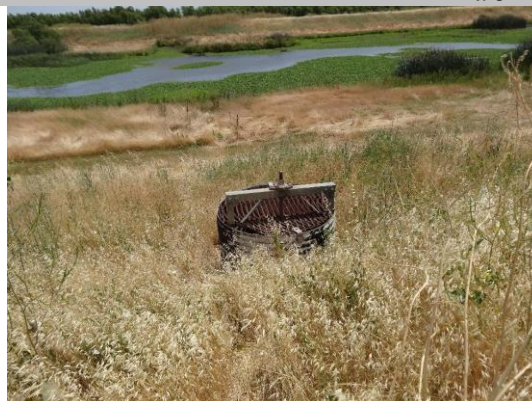
Photo 1 of 3 : UCIP\_SP\_2020\_55198\_23431.jpg

Comment Code					
Inspector Comment					
DS_ID:22626 FS_ID:55198 EP_NO: N/A Repair Type: Non-Urgent Crossing Status: Found UCIP Comments: 08/21/2019 Record has been updated from No Action Needed to Non-Urgent, due to a missing permit authorizing pipe and limited inspection due to dense vegetation on the LS. Dense vegetation prevented a thorough inspection on the LS slope and toe. Record updated with USACE O&M reference. (O. Magana - DWR UCIP)05/15/2013 - pipe submerged into water on landside. (P. Amatya - DWR UCIP) FIELD_STRUCT_DESC: 36-inch corrugated metal gravity drainage pipe through the levee, 16 feet below the crown. Slide gate in a 48-inch corrugated metal pipe (CMP) riser on the waterside (WS) slope. Concrete headwall at the landside (LS) toe. Pipe crosses under the channel. [Additional Reference(s): DWR Levee Log, 1993. USACE Sacramento O&M Manual, Unit 142 - Back Levee of Reclamation District No. 1001, June 1959, Revised 04 May 2018, 36-inch pipe (HLM 2.31)]. FS Date: 8/21/2019 12:55:00 PM

WS- slide gate on CMP on levee slope

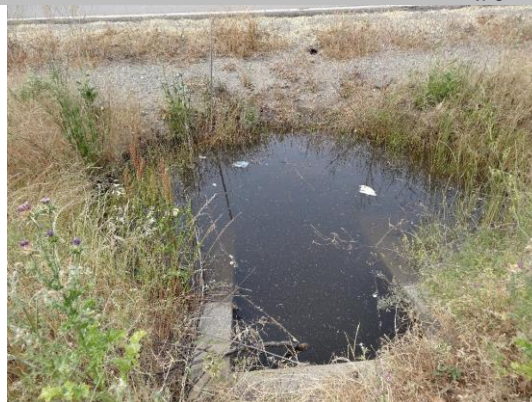
Photo 2 of 3 : UCIP\_SP\_2020\_55198\_23430.jpg

LS- headwall and submerged pipe. Pipe not visible due to water.

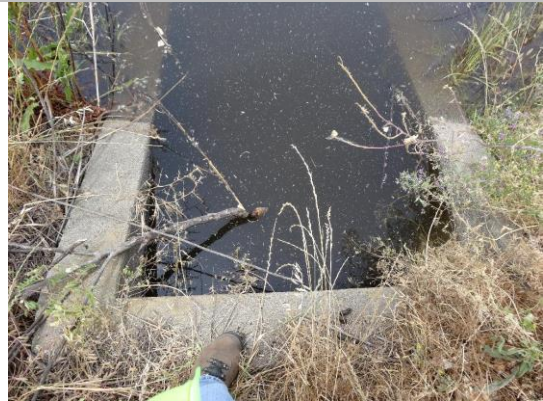
Photo 3 of 3 : UCIP\_SP\_2020\_55198\_23432.jpg

LS- headwall and submerged pipe

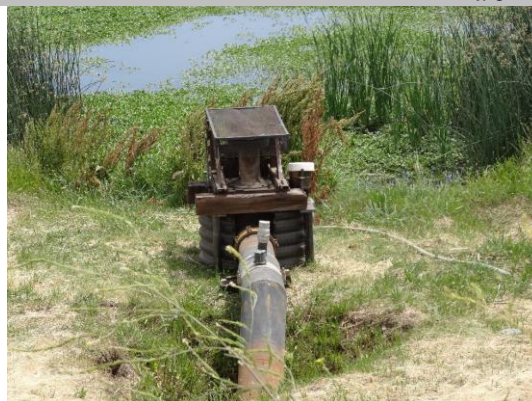
Photo 1 of 3 : UCIP\_SP\_2020\_55201\_23427.jpg

Comment Code					
Inspector Comment					
DS_ID:22622 FS_ID:55201 EP_NO: 12208 Repair Type: Non-Urgent Crossing Status: Found UCIP Comments: 08/21/2019 Crossing has been downgraded from Urgent to Non-Urgent, potential leak is more than 10 feet from WS toe. Still need to contact owner to determine the extent of WS repair. (O. Magana - DWR UCIP)10/18/2018 Same as previous inspection. No documentation is available to determine if there is a pipe integrity issue. Recommend internal inspection of the pipe through the levee to determine the condition of the pipe. Need to contact owner to obtain details of WS repair. Levee is about 8-10 feet high. Crossing remains Urgent due to the unknown reason for WS hole observed in the 2013 inspection (pipe repair or pipe leakage). (O. Magana - DWR UCIP)07/13/2016 Depression on WS berm has been backfilled, but the cause of the erosion was not addressed to my knowledge. As such, pipe integrity problem may still exist. Vegetation growth surrounds pipe on WS berm, in strike contrast to dry grass away from pipe alignment. This could be due to channel draining toward the pipe, or an indication of pipe leakage. (K. Fazel - UCIP)05/15/2013:- large pit at pipe daylight on WS berm, may be due to pipe leakage.- siphon breaker on LS shoulder not found. (P. Amatya - DWR) FIELD_STRUCT_DESC: 16-inch steel irrigation discharge pipe through the levee, 3 feet below the crown. 16-inch low-lift pump in the channel with a 1-inch electrical line also penetrating the levee to the power pole off the landside (LS) toe. 36-inch corrugated metal pipe (CMP) riser on the bank. Vent on the LS shoulder. Siphon breaker/vent on the apex of the pipe near the waterside (WS) pump. Standpipe off the LS toe. Pipe used seasonally only in the absence of groundwater, as per District President Joe Henderson. (16-inch irrigation pipe and 16-inch low-lift pump authorized under Permit No. 12208, 1977 - Thomas A. Cuguet). [Additional Reference(s): DWR Levee Log, 1993]. FS Date: 8/21/2019 12:51:00 PM

WS- pump and pipe on river bank

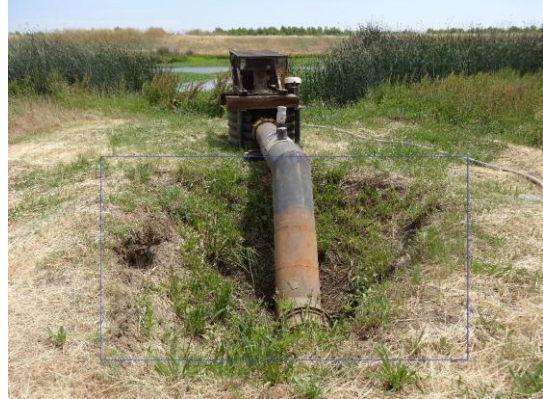
Photo 2 of 3 : UCIP\_SP\_2020\_55201\_23429.jpg

WS- large depression on levee berm

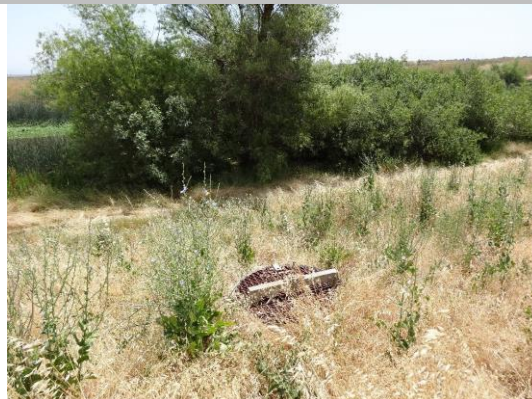
Photo 1 of 3 : UCIP\_SP\_2020\_55203\_23401.jpg

Comment Code						
Inspector Comment						
DS_ID:22628 FS_ID:55203 EP_NO: N/A Repair Type: Non-Urgent Crossing Status: Found UCIP Comments: 08/21/2019 Record has been updated from No Action Needed to Non-Urgent, no permit has been identified for crossing and dense vegetation limited inspection. Dense vegetation prevented a thorough inspection of pipe. DWR DMP internal inspection has not been completed. Record will be updated once the internal inspection is available to determine condition of pipe through the levee. Record updated with USACE O&M reference. (O. Magana - DWR UCIP)05/15/2013 - Headwall at the landside toe not found.- concrete box on landside toe. (P. Amatya - DWR UCIP) FIELD_STRUCT_DESC: 24-inch corrugated metal gravity drainage pipe through the levee, 12 feet below the crown. Slide gate in a 36-inch corrugated metal pipe (CMP) riser on the waterside (WS) slope. Concrete headwall at the landside (LS) toe. Pipe crosses under the channel. [Additional Reference(s): DWR Levee Log, 1993. USACE Sacramento O&M Manual, Unit 142 - Back Levee of Reclamation District No. 1001, June 1959, Revised 04 May 2018, 24-inch pipe (HLM 2.70)]. FS Date: 8/21/2019 12:55:00 PM

WS- slide gate on CMP riser on levee slope.

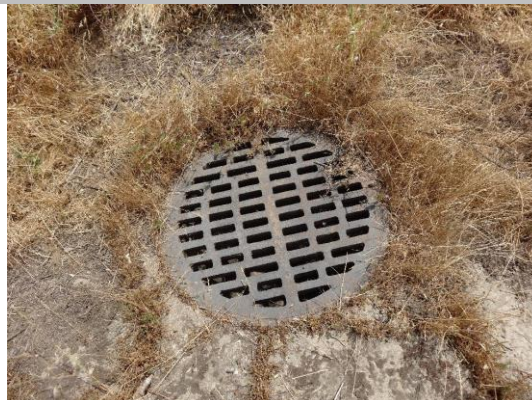
Photo 2 of 3 : UCIP\_SP\_2020\_55203\_23400.jpg

LS- a concrete box on landside toe.

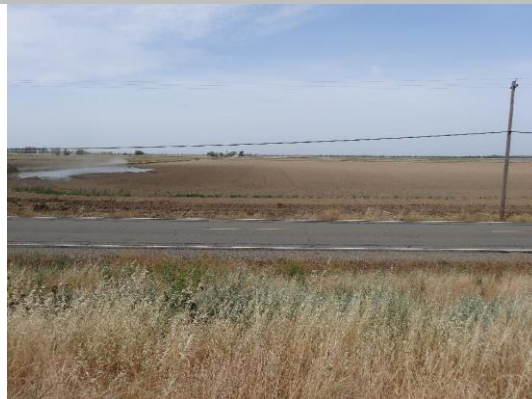
Photo 2 of 3 : UCIP\_SP\_2020\_55205\_23393.jpg

LS- no pipe/structure found on landside.

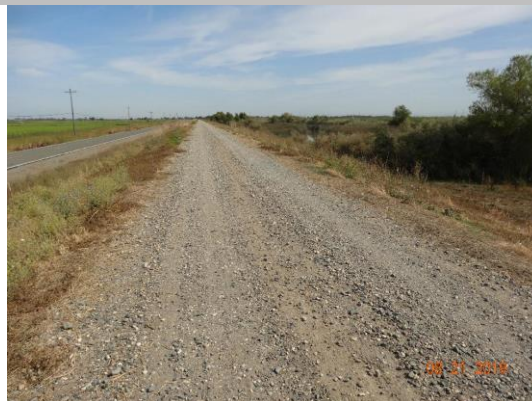
Photo 3 of 3 : UCIP\_SP\_2020\_55205\_81251.jpg

Overview of levee crown looking u/s towards pipe crossing.

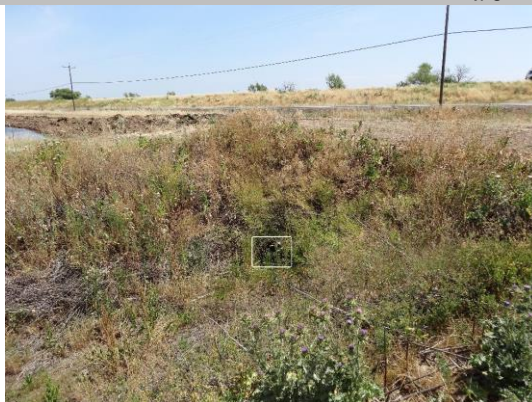
Photo 2 of 3 : UCIP\_SP\_2020\_55206\_23395.jpg

Comment Code					
Inspector Comment					
DS_ID:22630 FS_ID:55206 EP_NO: N/A Repair Type: Non-Urgent Crossing Status: Found UCIP Comments: 08/21/2019 Record remains Non-Urgent, no permit has been found and limited inspection prevented thorough inspection at crossing. Dense vegetation on LS slope and toe prevented a thorough inspection at pipe location. Record updated with USACE O&M reference. (O. Magana - DWR UCIP)05/15/2013 - pipe opens in irrigation ditch on landside.- vegetation cleaning on LS pipe opening. (P. Amatya - DWR UCIP) FIELD_STRUCT_DESC: 24-inch corrugated metal gravity drainage pipe through the levee, 12 feet below the crown. Slide gate in a 36-inch corrugated metal pipe (CMP) riser on the waterside (WS) slope. Concrete headwall at the landside (LS) toe. Pipe crosses under the channel. [Additional Reference(s): DWR Levee Log, 1993. USACE Sacramento O&M Manual, Unit 142 - Back Levee of Reclamation District No. 1001, June 1959, Revised 04 May 2018, 24-inch pipe (HLM 3.28)]. FS Date: 8/21/2019 12:56:00 PM

LS- CMP opens in irrigation ditch.

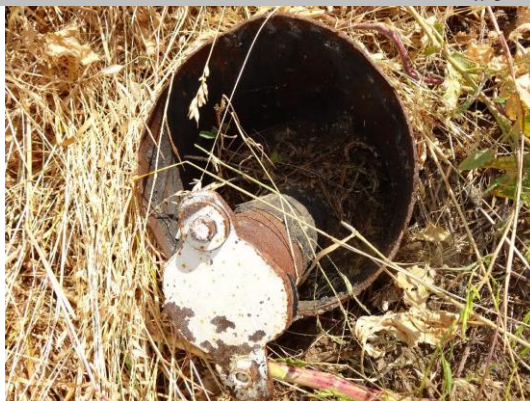
Photo 2 of 2 : UCIP\_SP\_2020\_54565\_22120.jpg

WS- gap between two pipes needs to be filled.

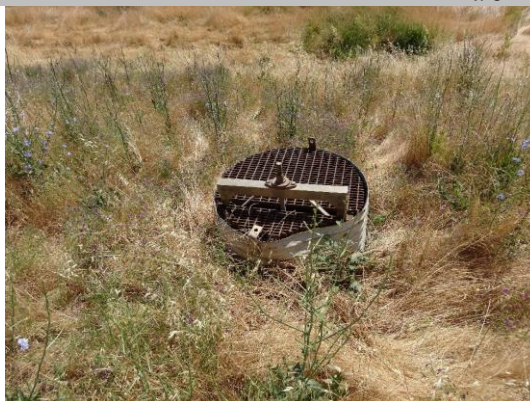
Photo 1 of 3 : UCIP\_SP\_2020\_55208\_22086.jpg

DS\_ID:22631  
 FS\_ID:55208  
 EP\_NO: N/A  
 Repair Type: Non-Urgent  
 Crossing Status: Found  
 UCIP Comments: 08/21/2019 Record remains Non-Urgent, due to limited inspection on the LS and missing permit. Dense vegetation on LS slope and toe prevented thorough inspection. Pipe description was updated with USACE O&M reference. (O. Magana - DWR UCIP)05/15/2013 Only a small section of head wall visible, almost buried. (P. Amatya - DWR UCIP)  
 FIELD\_STRUCT\_DESC: 24-inch corrugated metal gravity drainage pipe through the levee, 12 feet below the crown. Slide gate in a 36-inch corrugated metal pipe (CMP) riser on the waterside (WS) slope. Concrete headwall at the landside (LS) toe. Pipe crosses under the channel. [Additional Reference(s): DWR Levee Log, 1993. USACE Sacramento O&M Manual, Unit 142 - Back Levee of Reclamation District No. 1001, June 1959, Revised 04 May 2018, 24-inch pipe (HLM 3.59)].

WS- fixed slide gate in CMP riser on levee slope.

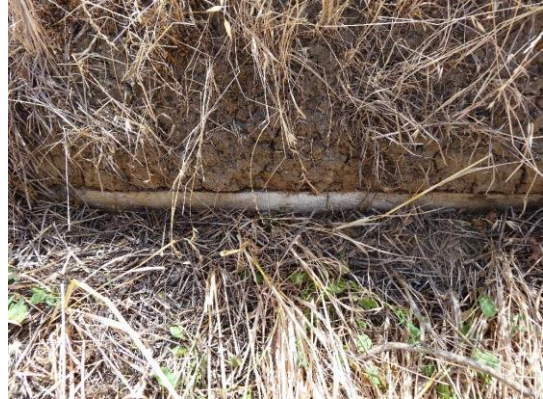
Photo 2 of 3 : UCIP\_SP\_2020\_55208\_22085.jpg

LS- almost buried concrete headwall. Only upper portion of the wall is visible.

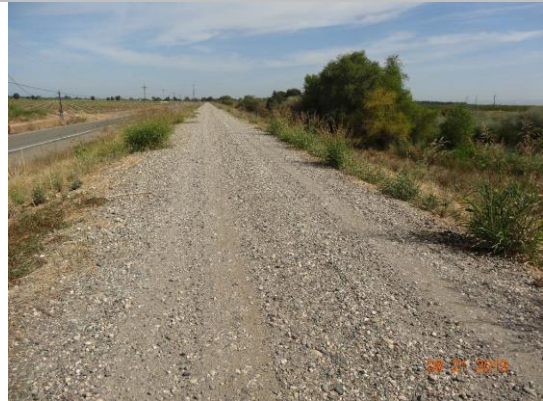
Photo 3 of 3 : UCIP\_SP\_2020\_55208\_81262.jpg

Overview of levee crown looking u/s towards pipe crossing.

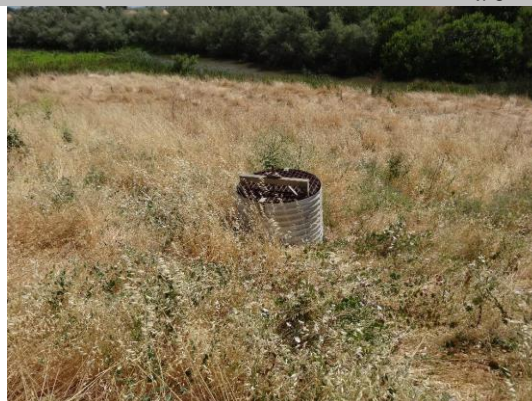
Photo 1 of 3 : UCIP\_SP\_2020\_55209\_22046.jpg

Comment Code						
Inspector Comment						
DS_ID:22632 FS_ID:55209 EP_NO: N/A Repair Type: Urgent Crossing Status: Found UCIP Comments: 08/21/2019 Record remains Urgent, pipe wall at the inlet has failed. DMP internal video inspection has not been completed to determine extent of damage through the levee. Dense vegetation on LS prevented a thorough inspection. Record updated with USACE O&M reference. (O. Magana - DWR UCIP)10/30/2018 Photos of the pipe failure, visible from the LS inlet, were uploaded. Crossing remains Urgent due to the deteriorated condition of the pipe. Recommend internal inspection through the levee. (O. Magana - DWR UCIP)10/18/2018 Unable to access the LS toe due to muddy conditions. Assume no repairs have been done to this crossing to date. This crossing is part of DWR's Deferred Maintenance Project (DMP). Based on the photos taken in 2013 and 2016 the pipe section through the wall has missing pipe sections due to heavy corrosion. Recommend repair to avoid further deterioration of pipe section through levee. Levee is about 8-10 feet high. Crossing remains Urgent based on the deteriorated condition of the pipe on the LS. (O. Magana - DWR UCIP)07/13/2016 Same condition as last. Pipe heavily corroded and partially filled with debris and straw. (K. Fazel - UCIP) 05/15/2013:- mud/soil debris on LS pipe end.- highly corroded pipe in outlet.- may require video inspection or pressure test. (P. Amatya - DWR) FIELD_STRUCT_DESC: 24-inch corrugated metal gravity drainage pipe through the levee, 12.2 feet below the crown. Slide gate in a 36-inch corrugated metal pipe (CMP) riser on the waterside (WS) slope. Concrete headwall at the landside (LS) toe. Pipe crosses under the channel. [Additional Reference(s): DWR Levee Log, 1993. USACE Sacramento O&M Manual, Unit 142 - Back Levee of Reclamation District No. 1001, June 1959, Revised 04 May 2018, 24-inch pipe (HLM 3.93)]. FS Date: 8/21/2019 12:51:00 PM

WS- slide gate, air vent in CMP riser on levee slope

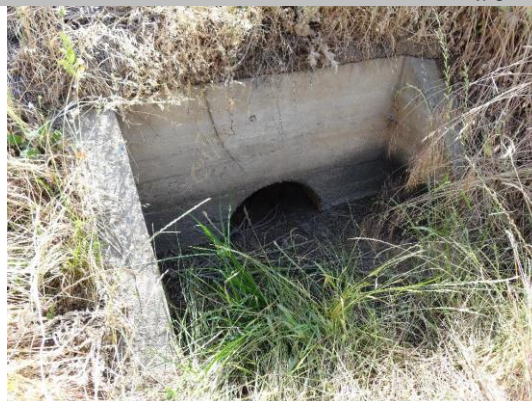
Photo 2 of 3 : UCIP\_SP\_2020\_55209\_22045.jpg

LS- CMP in concrete head/wing wall outlet

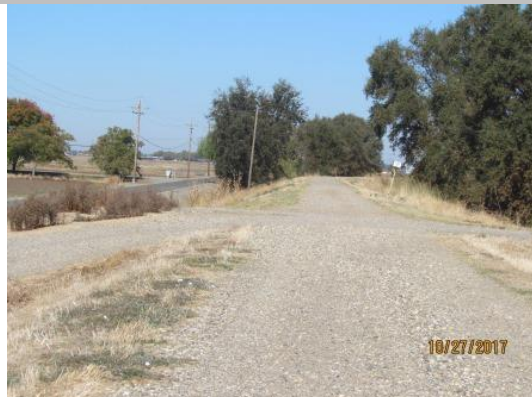
Photo 1 of 1 : SP\_2020\_RD1001\_40\_19\_20200227\_00006.jpg

LM Start	4.33	Rating **	A/W	Issue No.	19
LM End	4.33	Issue Type +	Ma	Location *	CR
Category	Earthen Levee			GPS Latitude/Longitude	
				Start	End
Item	Crown Surface / Depressions / Rutting			38.892999 °	38.892999 °
				-121.524711 °	-121.524711 °
DWR ID	DWR_RD1001_06_f_2013_19				
Comment Code					
C2 : Repair depressions or ruts in the crown or slope.					
Inspector Comment					
There are depressions on the crown where there is cross traffic. Monitor this area and fix as needed.

View of crown where there is cross traffic looking upstream. Monitor this area and fix as needed.

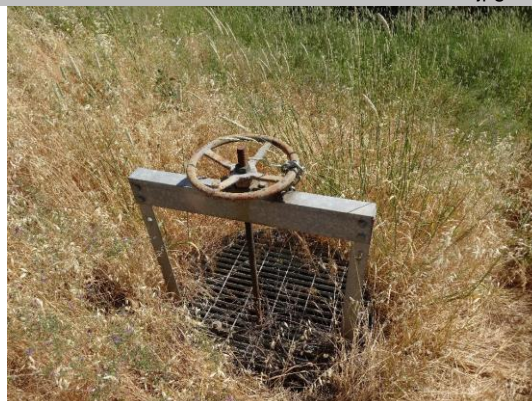
Photo 1 of 3 : UCIP\_SP\_2020\_55210\_22034.jpg

Comment Code					
Inspector Comment					
DS_ID:22618 FS_ID:55210 EP_NO: N/A Repair Type: Urgent Crossing Status: Found UCIP Comments: 08/21/2019 Record has been updated from Non-Urgent to Urgent, due to potential levee integrity. Scour hole visible at WS toe that appears to be within the project prism. No permit has been found authorizing this crossing. Record updated with USACE O&M reference. (O. Magana - DWR UCIP)05/15/2013 - damaged head/wing wall in inlet structure. (P. Amatya - DWR UCIP) FIELD_STRUCT_DESC: 30-inch corrugated metal gravity irrigation pipe through the levee, 15.9 feet below the crown. Slide gate in a 36-inch corrugated metal pipe (CMP) riser on the waterward slope. Pipe discharges into a large irrigation ditch on the west side of Pacific Avenue. (Joplin and South Sutter Water District). [Additional Reference(s): DWR Levee Log, 1993. USACE Sacramento O&M Manual, Unit 142 - Back Levee of Reclamation District No. 1001, June 1959, Revised 04 May 2018, 30-inch pipe (HLM 4.38)]. FS Date: 8/21/2019 12:58:00 PM

WS- slide gate in CMP riser.

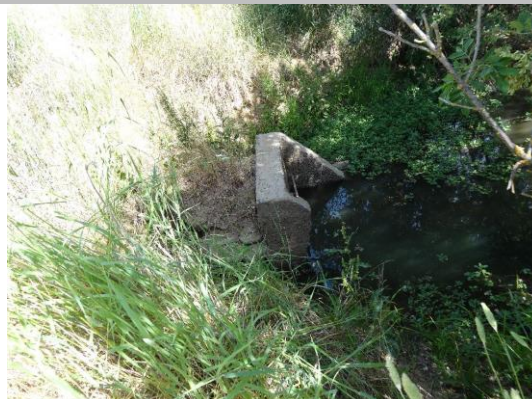
Photo 2 of 3 : UCIP\_SP\_2020\_55210\_22033.jpg

LM Start	<b>4.36</b>	Rating **	U	Issue No.	<b>61 (cont)</b>
LM End	<b>4.36</b>	Issue Type +	En	Location *	
Category	Supplemental		GPS Latitude/Longitude		
			Start	End	
Item	DWR UCIP Field Study		38.893448 °	38.893448 °	
			-121.524719 °	-121.524719 °	
DWR ID	22618

WS- inlet wing wall with trashrack

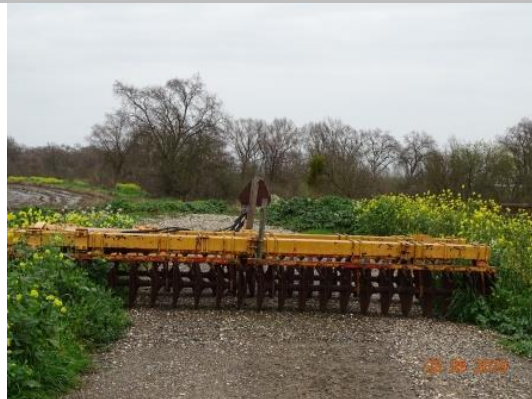
Photo 1 of 2 : SP\_2020\_RD1001\_40\_24\_20200227\_00009.jpg

LM Start	4.71	Rating **	M	Issue No.	24
LM End	4.71	Issue Type +	En	Location *	CR
Category	Earthen Levee			GPS Latitude/Longitude	
				Start	End
Item	Encroachments			38.896310 °	38.896310 °
				-121.520674 °	-121.520674 °
DWR ID	DWR_RD1001_06_f_2016_24				
Comment Code					
EQ : Equipment					
Inspector Comment					
Old piece of pipe still lying on landside levee slope, and equipment on levee crown. Fall 2019.

View looking upstream on crown of a piece of equipment that prohibits access, Spring 2019.
